Case Report

Malpositioned Right Ureteral Stent into the Duodenum: A Rare Case Report

Department Of Urology, Apollo Main Hospital, Chennai, Tamil Nadu, India

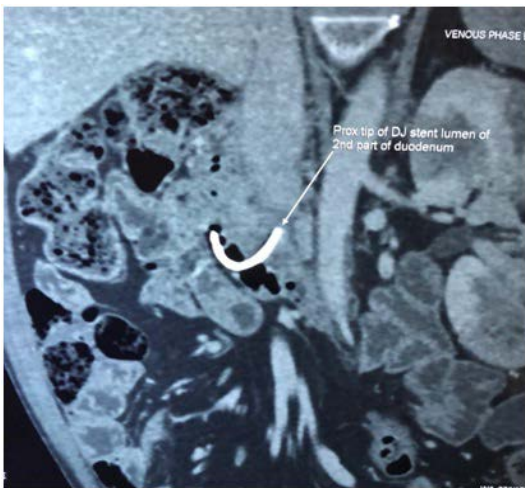
Figure 1. Proximal Tip of DJ Stent Seen in the Lumen of the Second Part of Duodenum

He then presented to our outpatient clinic with chronic dull right flank pain for evaluation and for right DJ stent removal. Blood test analysis showed that the serum creatinine was 1.4 mg/dL (123.79 umol/L) with normal WBC count. An abdominal CT was performed which revealed a malpositioned right DJ stent with the tip of the proximal coil in the second part of duodenum (Figure 1), and the distal tip in urinary bladder. The right kidney showed evidence of hydronephrosis (Figure 2). There was no evidence of the previously seen RP mass (suggesting that it had resolved on previous long-term antibiotics). The excretory phase showed a shrunken, poorly functioning right kidney (Figure 3).

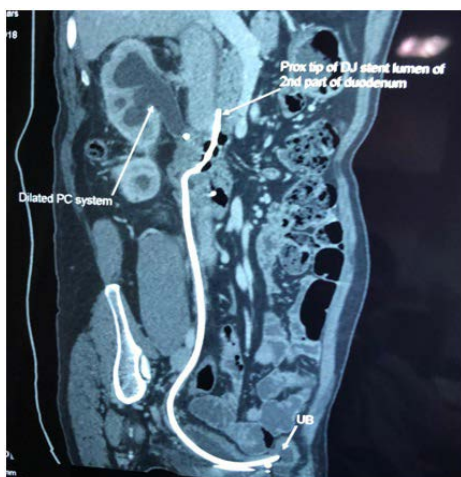
Figure 2. 320 Slice CECT Abdomen Showing a Right Small Hydronephrotic Kidney, the Upper Part of the DJ Stent Uncoiled and Malpositioned into Duodenum while the Rest of the Stent was Properly Positioned

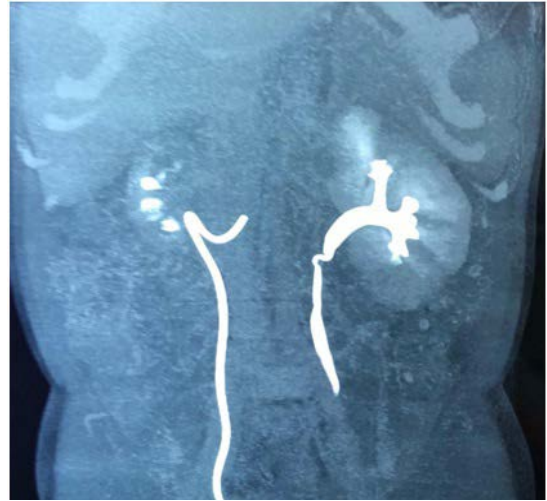
Figure 3. Contracted Right Poorly Functioning Kidney with Uncoiled Proximal DJ Stent Coil

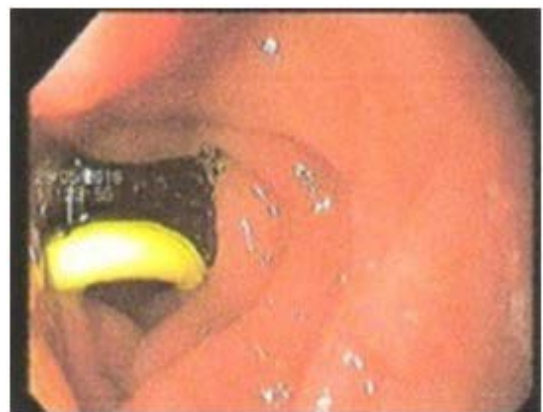
We consulted with the Gastroenterology Department and upper GI endoscopy showed the upper coil of the DJ stent in the second part of duodenum (Figure 4), confirming the CT findings. A renogram was performed which revealed 8% right split renal function. With these findings a laparoscopic right nephrectomy with right DJ stent removal was planned.

Figure 4. Upper GI Endoscopy Confirming DJ Stent Tip in Second Part of the Duodenum

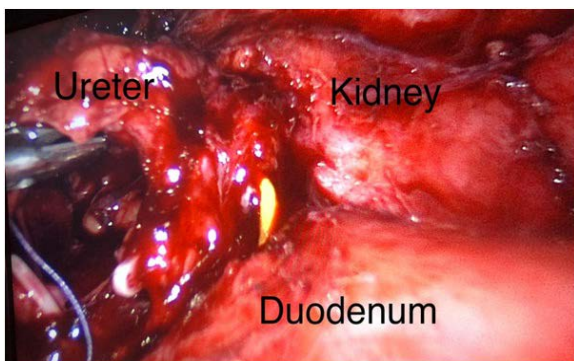
Under general anaesthesia, in the left lateral decubitus position, pneumoperitoneum was created using a Veress needle and standard laparoscopic ports placement done. The right colon was mobilised and dropped down, with great difficulty the right ureter was identified amidst dense adhesions (presumably due to the previous retroperitoneal inflammatory mass). The duodenum was found stuck to the right renal pelvis and the upper ureter and was mobilized by further gentle dissection. During these maneuvers, the DJ stent entering into duodenum suddenly appeared through a very tiny orifice (Figure 5). The upper coil was extracted from the duodenum and the entire stent was removed from the ureter

Figure 5. Intra OP Picture Showing Proximal Part of DJ Stent Entering into the Duodenum from the Upper Ureter, Observed while Mobilising the Duodenum from the Renal Pelvis and Upper Ureter

and retrieved through one of the ports. The duodenum was then inspected, revealing a very small opening without leakage of intestinal material. The defect was closed with two interrupted 2-0 vicryl sutures and reinforced with an omental patch. Subsequently, right nephrectomy was performed, and the specimen retrieved through extension of one of the port site in right iliac fossa. A drain was placed and the abdominal opening and port sites were closed.
